Evaluation of the small female side impact dummy in current and future side impact test procedures

APROSYS

**Integrated Project on
Advanced Protection Systems**

Deliverable D5.2.12

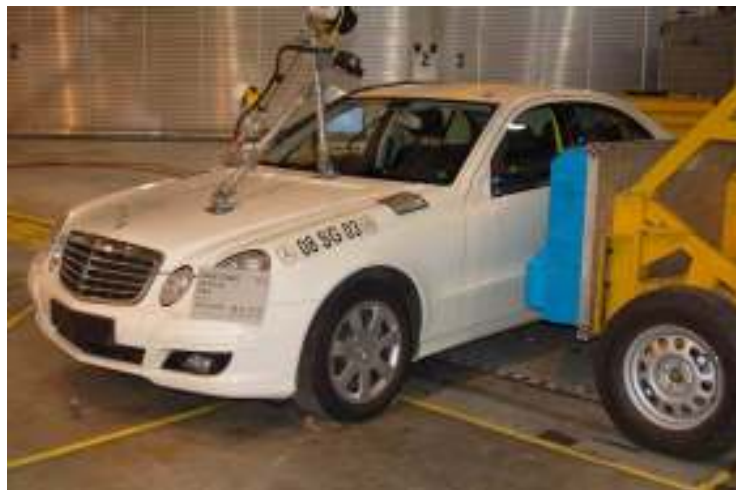
Figure 3: Crash set up overview E-class

Full Scale Side impact crash test, in accordance to IIHS (Version V, April 2008) with following vehicle:

Type: Daimler AG, E-Class
W211
Market: -
Driver side: LHD

Speed tolerance IIHS: 50 km/h \pm 0.8 Actual impact velocity: 50,08 km/h
Barrier weight: 1500 kg

Driver Dummy type: WorldSID 5th Dummy No: WF SN002
Passenger Dummy type: WorldSID 5th Dummy No: WF SN001

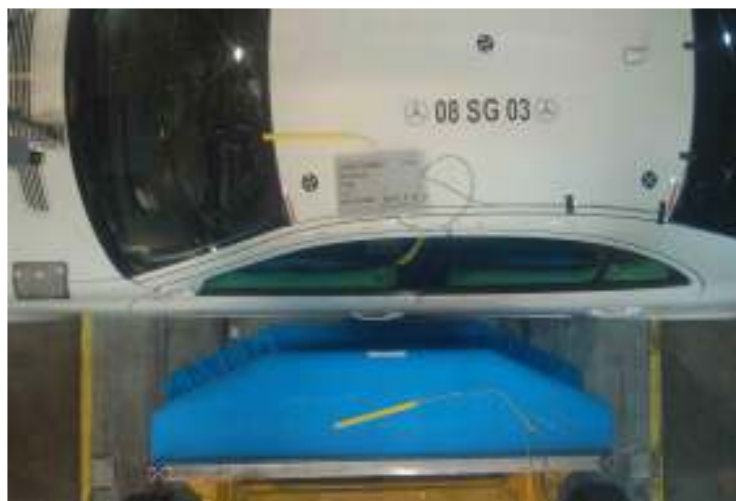
Figure 4: Top view of crash set up E-class

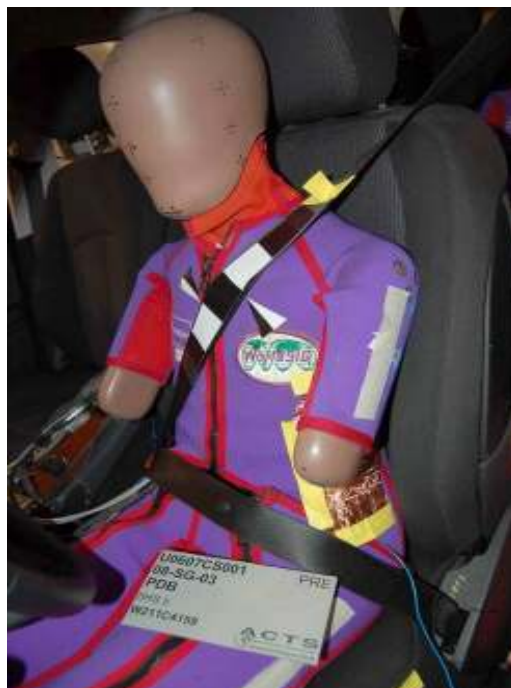
Figure 7: Driver Detail E-class

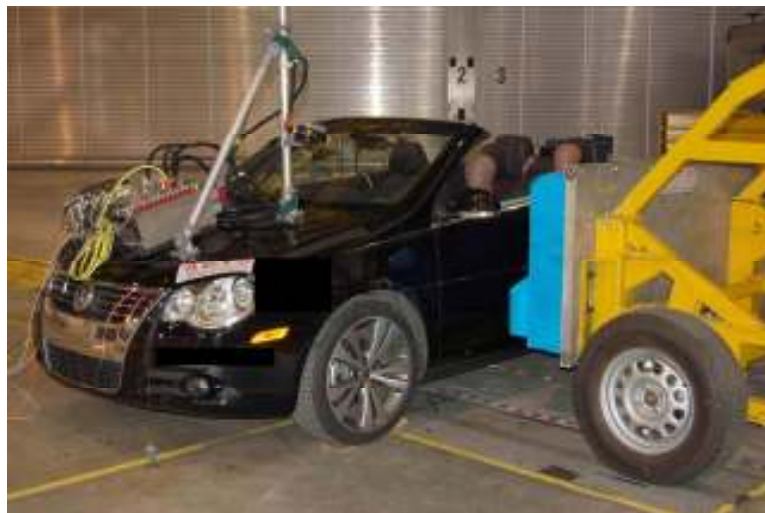
Figure 8: Crash set up overview VW EOS

Full Scale Side impact crash test, in accordance to IIHS (Version IV, April 2005) with following vehicle:

Type: Volkswagen, Eos
Market: -
Driver side: LHD
Vehicle Ident no.: -
Vehicle no.: -

Driver	Dummy type:	WorldSID 5th	Dummy No: WF SN001
Passenger	Dummy type:	WorldSID 5th	Dummy No: WF SN002

Speed tolerance IIHS: 50 km/h \pm 0.8 Actual impact velocity: 50.05km/h
Barrier weight: 1500 kg

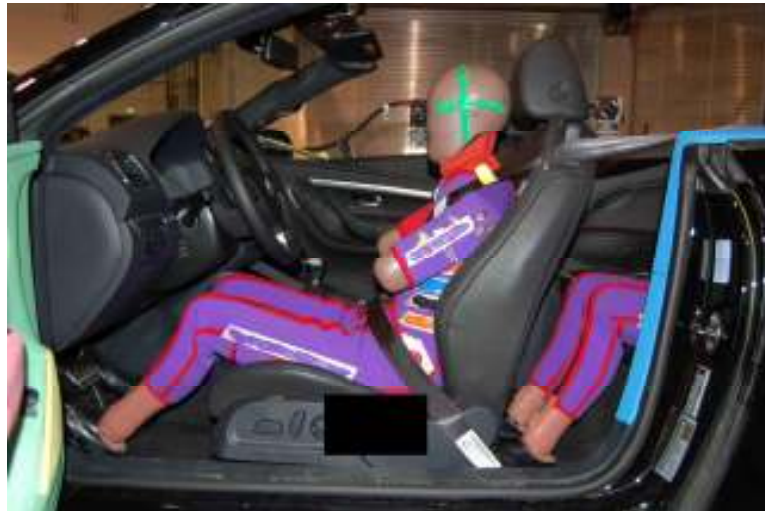
Figure 10: Driver Overview EOS

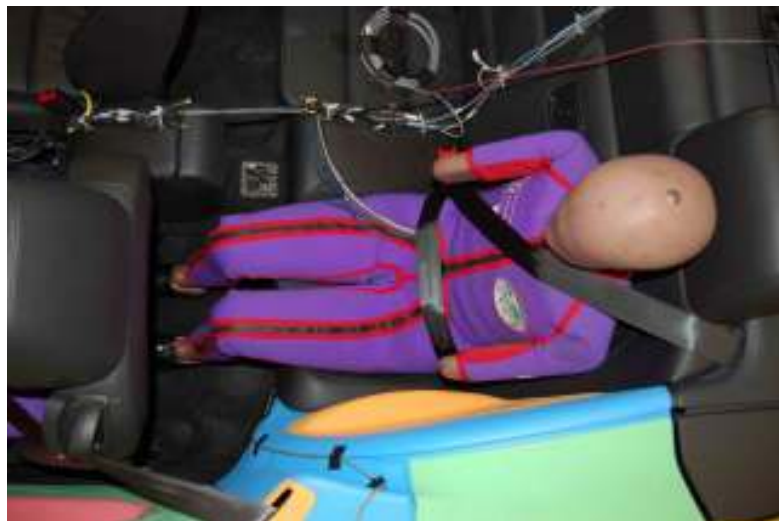
Figure 11: Top view passenger

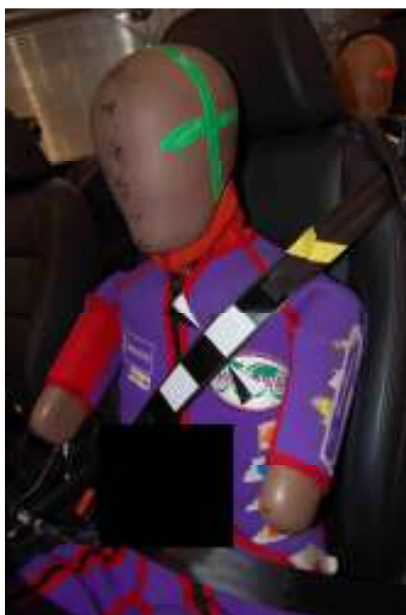
Figure 12: Driver Detail EOS

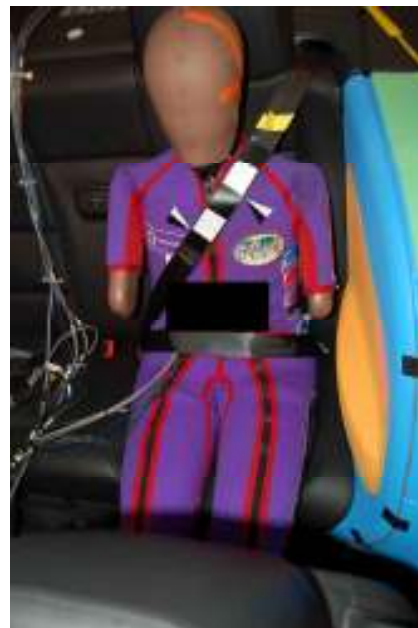
Figure 13: Passenger Detail EOS

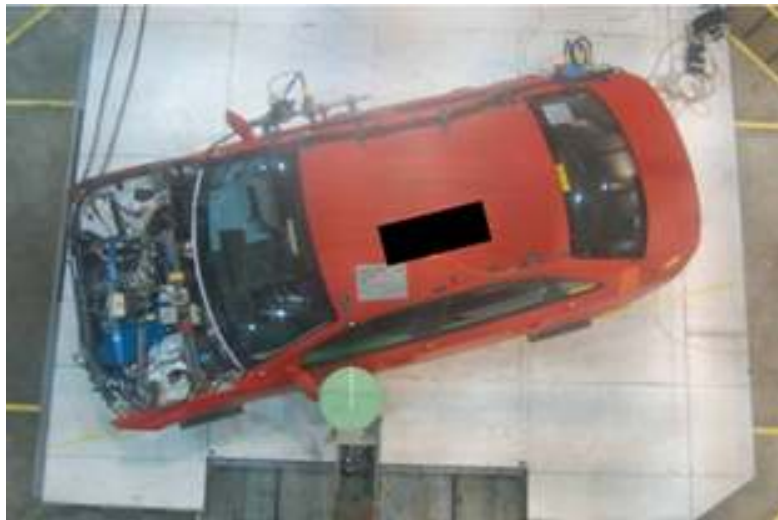
Figure 14: Top view oblique pole crash set-up

Testtype: FMVSS 214 pole 75° side impact left (velocity 32 km/h)
Testobject: Audi A4 (2008), 4-door mid size car
Driver Side: LHD
Restraint – Systems: 3 point safety belt, pretensioner, side airbag (thorax), curtain (head)
Dummy: WorldSID 5th percentile female dummy

Rated velocity FMVSS 214: 32 km/h
Actual impact velocity: 32.28 km/h

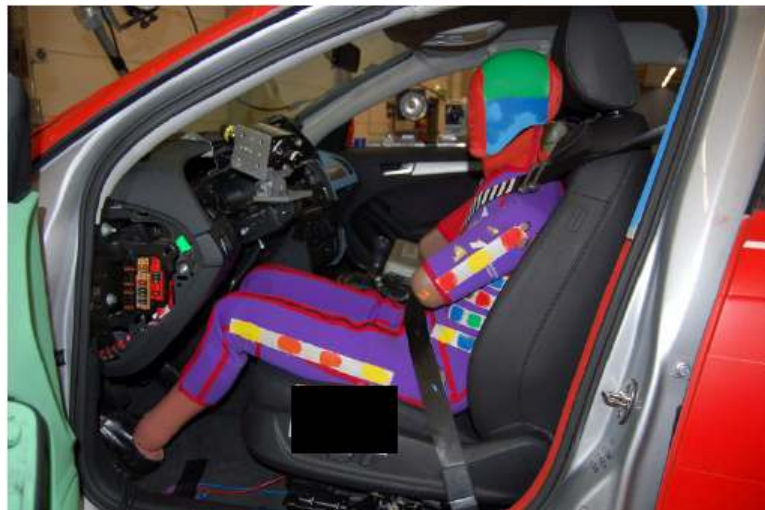
Figure 15: Driver position
